TYPE 1 RECONNAISSANCE LEVEL CHARACTERIZATION REPORT (RLCR)/PRE-DEMOLITION SURVEY REPORT (PDSR)

SEWAGE TREATMENT PLANT CLOSURE PROJECT (Buildings 995-D1 and 995-D2)

REVISION 0

January 25, 2005

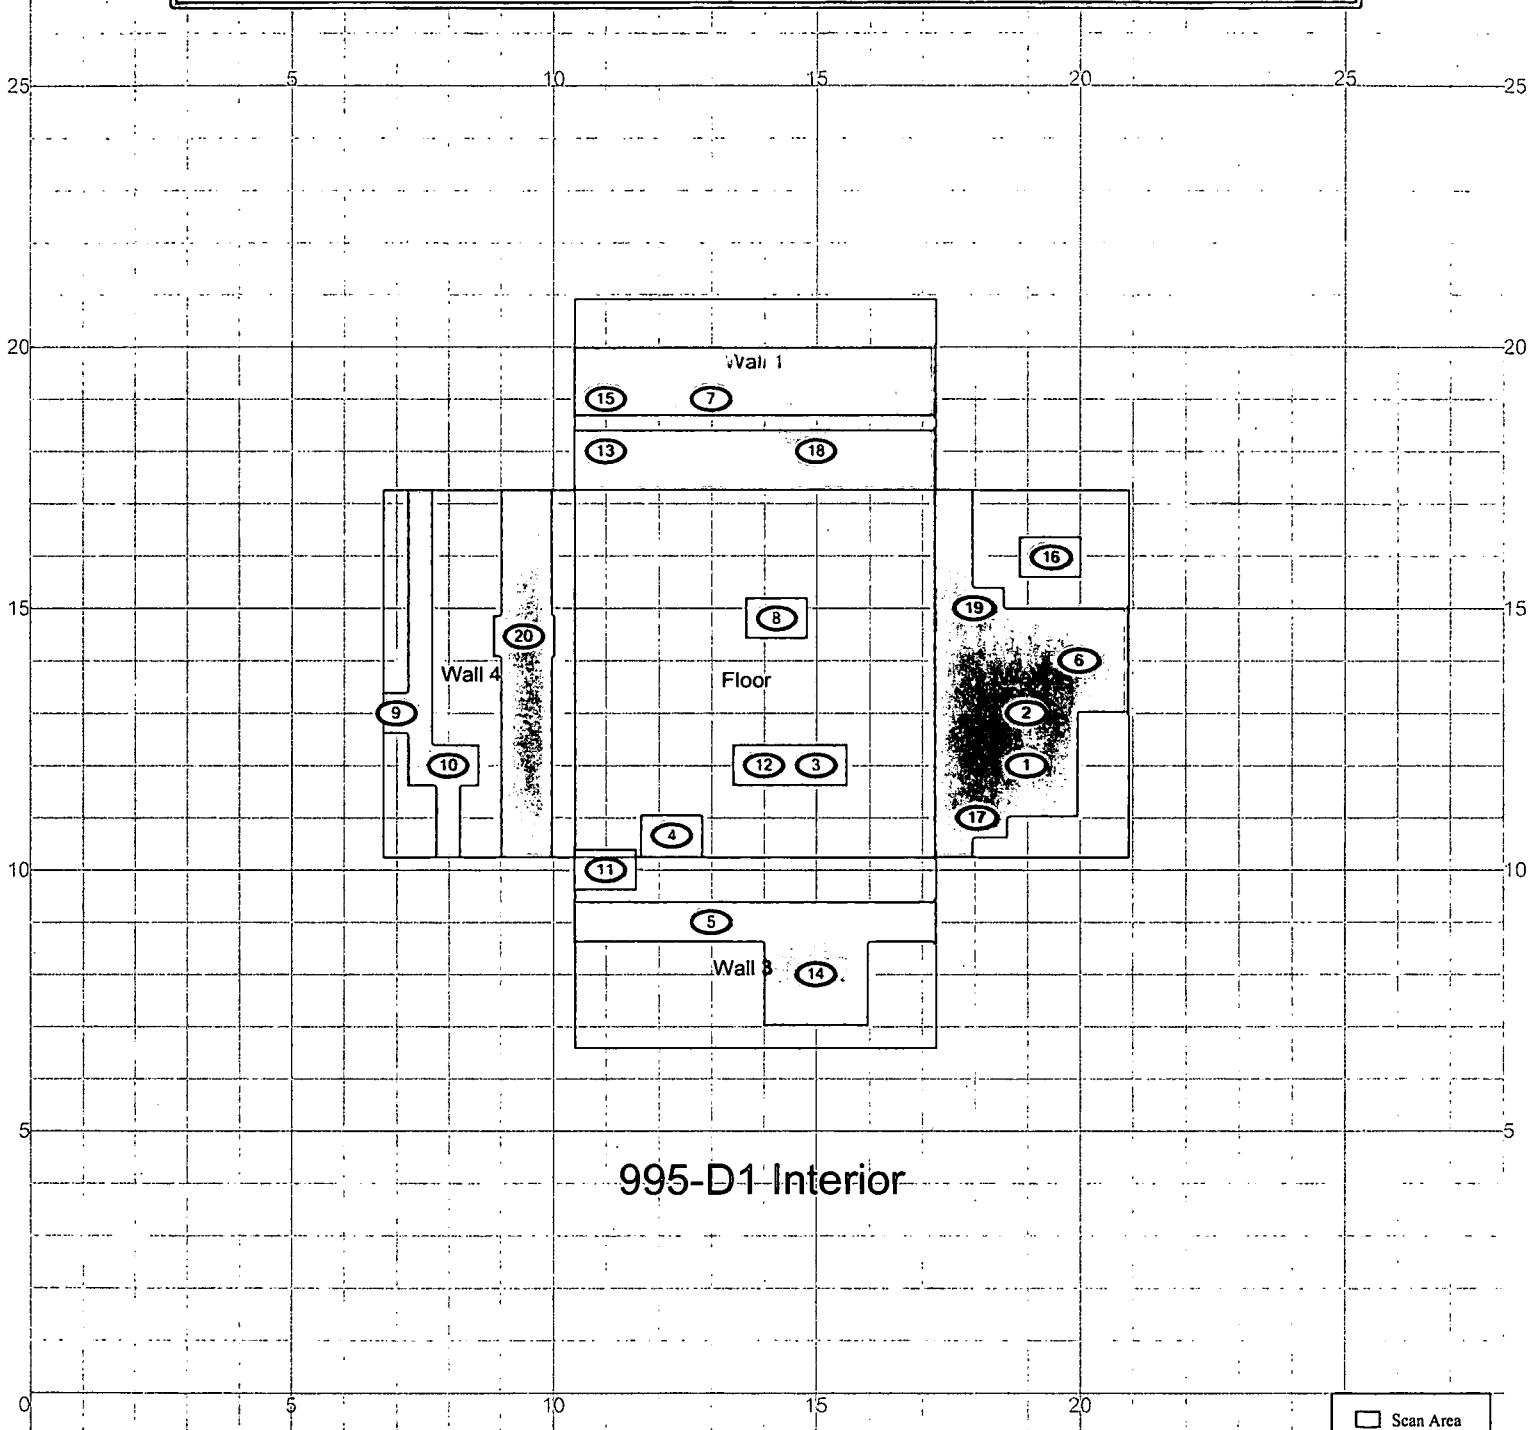
995-D1 Interior

Survey Area: 5 Survey Unit: 995D01 Classification: 3
 Building: 995-D1
 Survey Unit Description: 995-D1 Digester Interior
 Total Area: 150 sq. m. Floor Area: 48 sq. m.

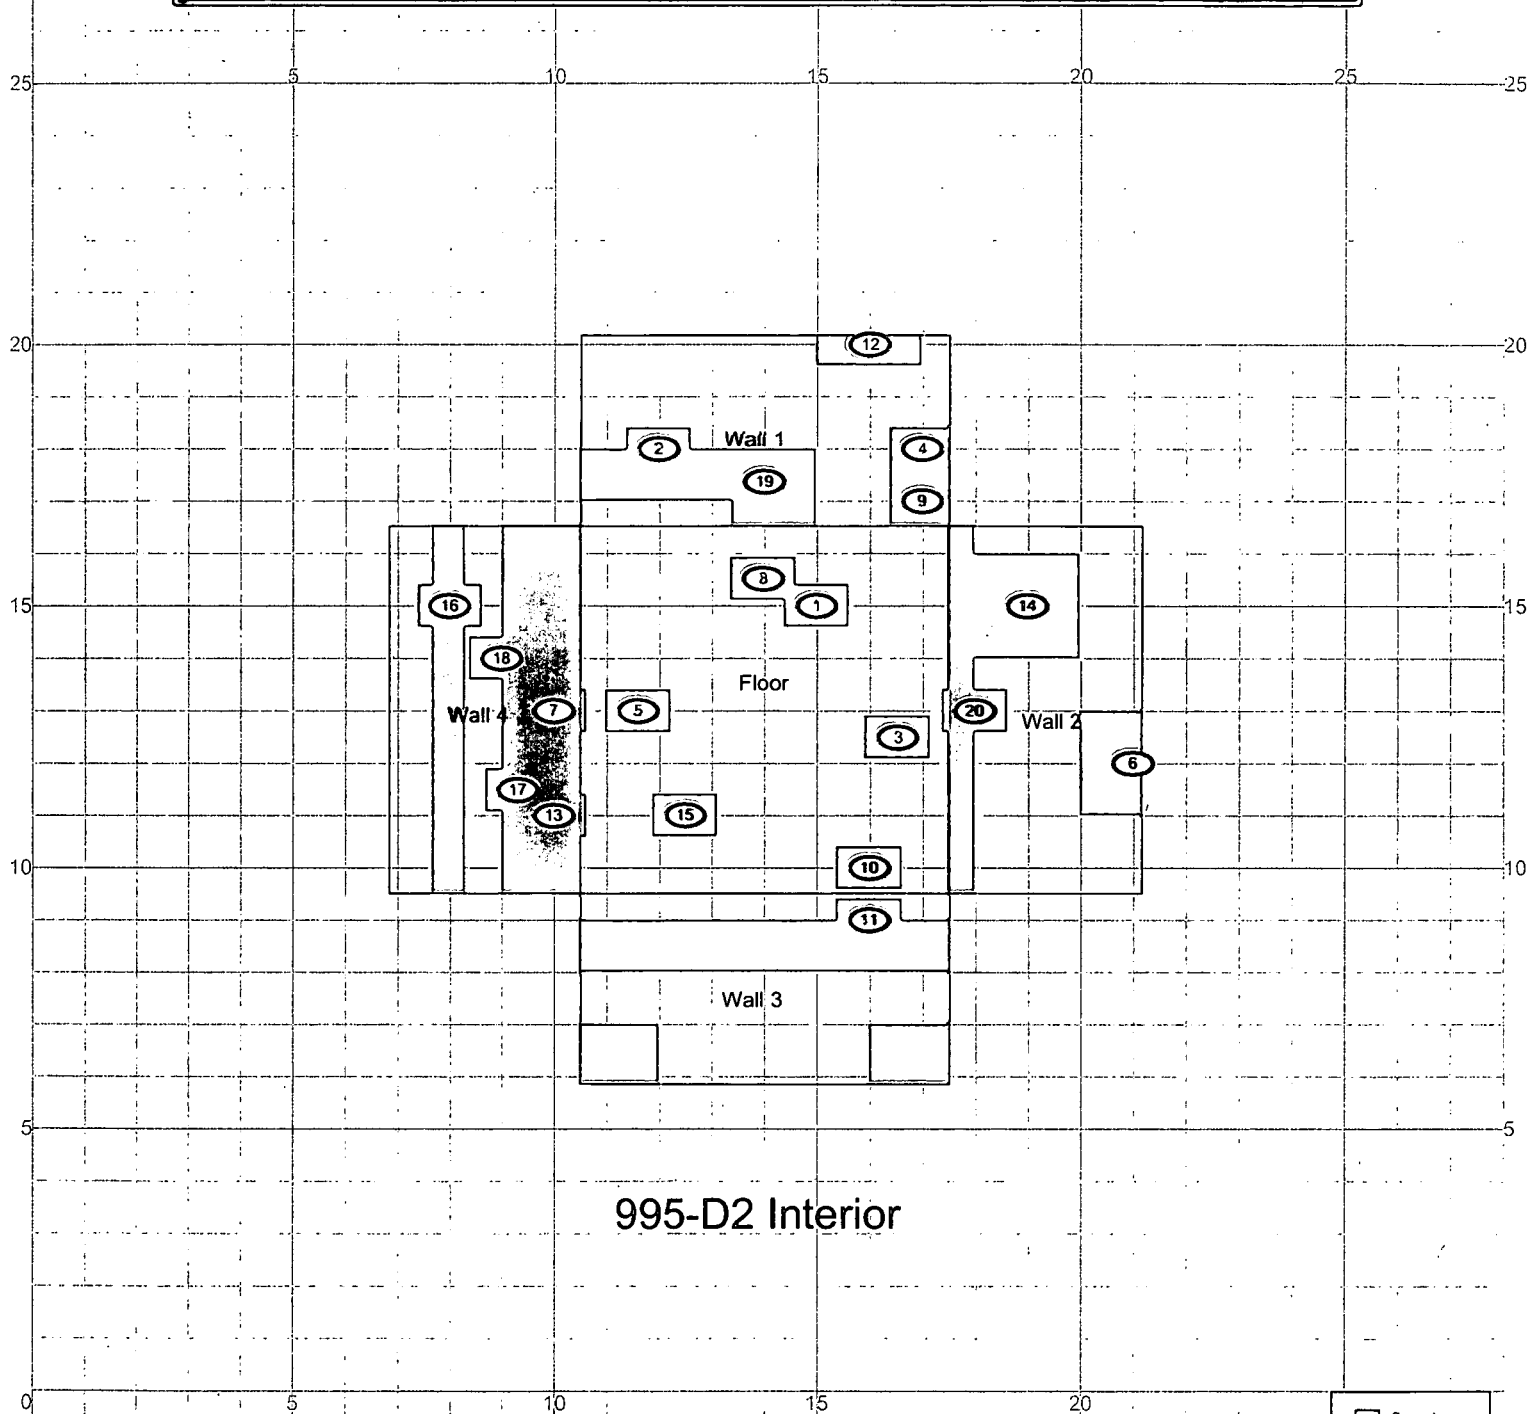
995-D2 Interior

Survey Area: 5 Survey Unit: 995D02 Classification: 3
 Building: 995-D2
 Survey Unit Description: 995-D2 Digester Interior
 Total Area: 150 sq. m. Floor Area: 48 sq. m.
